Technical Insight

Title: Why does the coating appear “cracked” on my evaluation coupon? – A tale of two sides

Author(s): Min Yuan

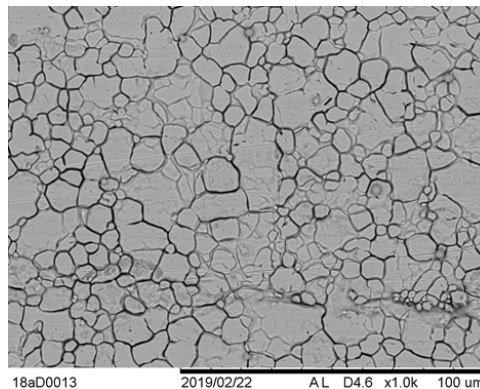
Figure 1) SEM image (1000x) of a SN2000-coated 316SS evaluation coupon shared by a SilcoTek customer

This TI summarizes an investigation in response to a customer complaint. The reported cracks in the coating observed by the customer in SEM were confirmed to be in fact stainless steel metal grains, as a result of the unpolished surface finish. SilcoTek's CVD coating is very thin (sub-micron) and in general will not mask the microstructures of the underneath substrate. The features of the metal itself will show up in SEM examinations, and to minimize this, polished surfaces are usually preferred if one wishes to evaluate the surface morphology of the coating itself.

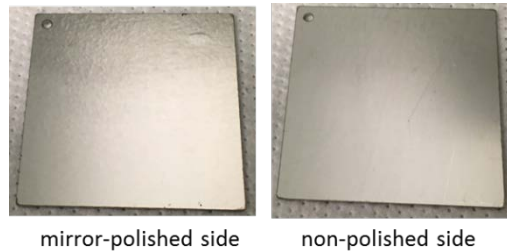
It turns out that the two sides of the evaluation coupons are not equivalent; one side has a mirror-polished finish, whereas the back side has a standard machine-finish (see Figure 2 below). With the coating on, it is not always immediately obvious by visual inspection which side has the polished finish. To look for one’s own reflection in the coupon is the easiest way to identify the two sides.

Figure 2) the two sides of an uncoated evaluation coupon

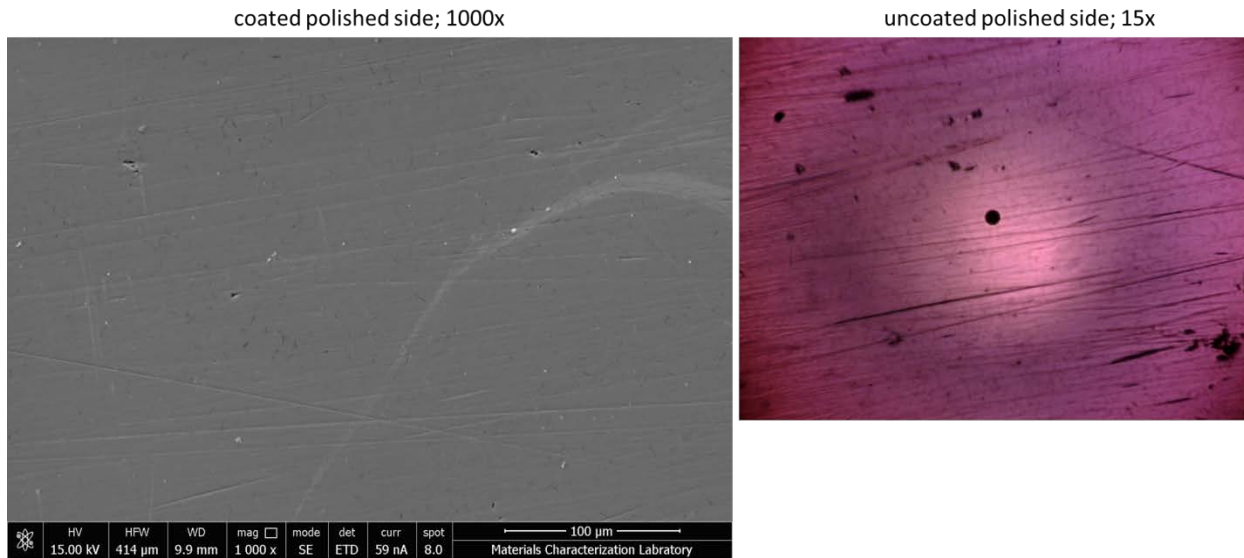
Figure 3) SEM (left) and optical microscope (right) images of the mirror-polished side of an evaluation coupon

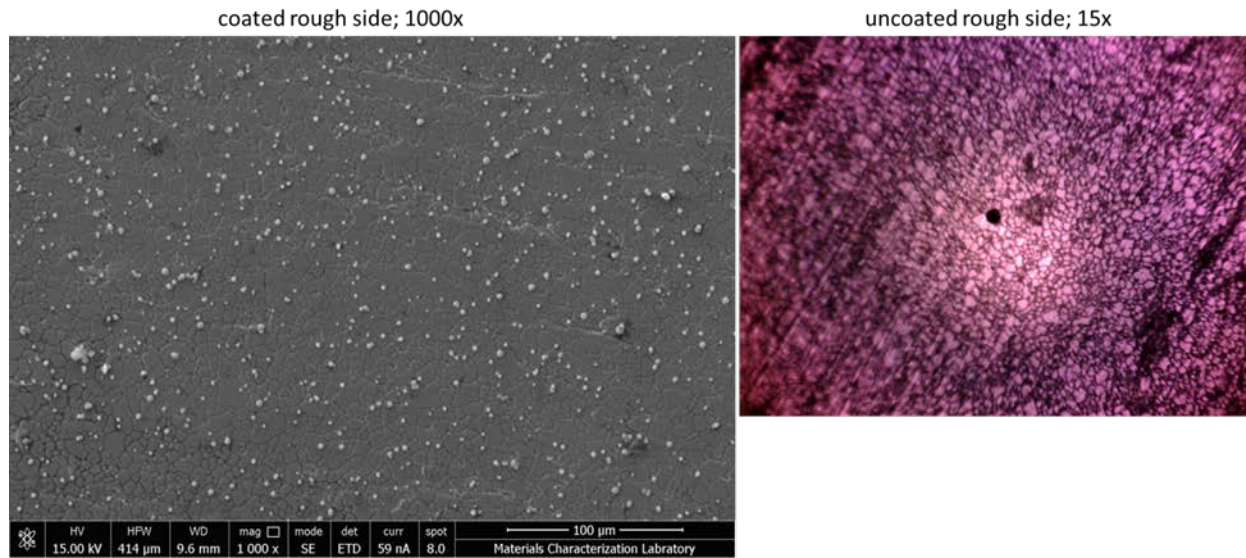
After realizing this, the unpolished side of the return coupon was examined under the SEM by SilcoTek, which revealed the “cracks” described by the customer. These “cracks” are in fact the stainless steel metal grains that become visible under high magnification, and after a mirror polish, are smoothed out and no longer show up under the SEM. Figures 3 and 4 below show both sides under the SEM (1000x) with coating on. To confirm that the “cracks” are indeed from the metal itself, uncoated as-received coupons were also examined under optical microscope, to demonstrate the differences of the two finishes on the two sides. Linear polarization resistance scans using 5% HCl solution as the electrolyte were also performed on both sides of a coated coupon. Actual coating cracks would inevitably lead to poor corrosion performance and would be detected by this test. The measured corrosion currents for both sides were comparable, further confirming the integrity of the coating itself on the non-polished side.

Figure 4) SEM (left) and optical microscope (right) images of the unpolished side of an evaluation coupon
