## Metal ion leaching study part 4: Ultrapure DI water corrosion.

### Technical Insight

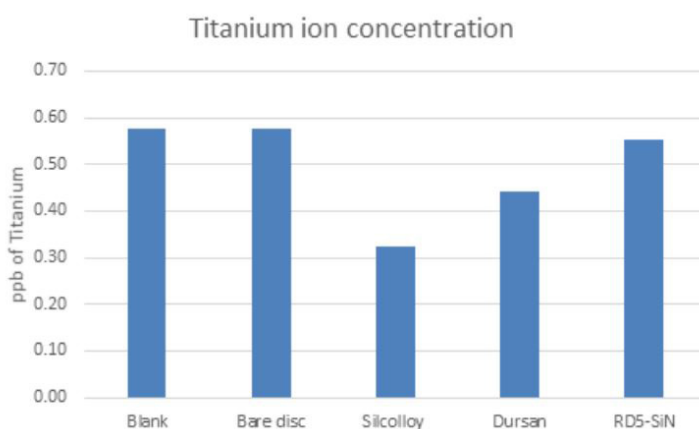
The results for the titanium discs can be seen in Figure 1. All values were within the detection limit of the instrument for titanium (0.2 ppb) showing that in ultrapure DI water, no titanium ions leach into the solution. This is strikingly different than the methanol study where 14 ppb of titanium were leached into the methanol. Dursan and RD5-SiN seemed to exacerbate these result (21ppb and 57 ppb respectively). Previous studies have shown that if titanium has access to water, it will passivate the surface and not allow the pitting of the titanium surface and the release of ions into the solution.<sup>1</sup> This also explains observations of De Pra and his group at Thermo Fisher Scientific where they investigated titanium contamination of their HPLC system.<sup>2</sup> They found that the silica bed in the column can be poisoned with titanium if using pure methanol and a titanium sintered filter in the solvent bottle. Switching the solvent from pure methanol to just 5% water was sufficient to prevent the metal ion leaching into their system.

*Figure 1: Titanium ion leaching in pure DI water. Blank refers to no sintered disc placed in the liquid to act as a control. All samples showed no titanium ion leaching into solution.*

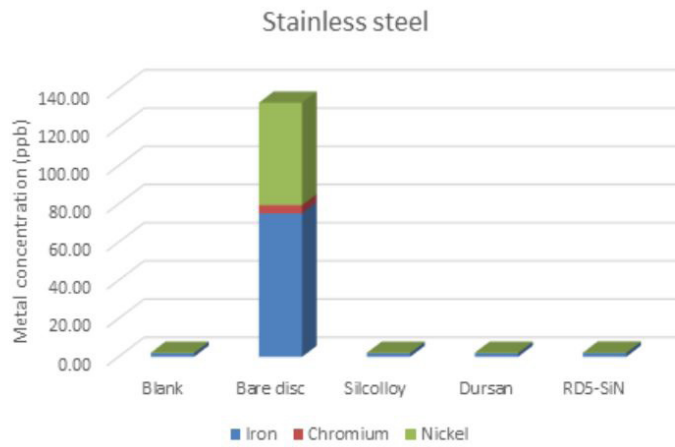
The 316 stainless steel disc results can be seen in Figure 2. It is obvious that the coatings on the sintered metal discs blocks the metal ions from leaching into solution. While there was substantial metal ion leaching into the solution, it was far less than experienced in the previous studies using methanol. Specifically, the iron and chromium levels were roughly an order of magnitude lower, as shown in Table 1. The nickel concentration is relatively unaffected by the solvent choice. The surface of 316 stainless steel has an oxide layer, largely consisting of chromium oxide, but also containing iron and nickel oxides. This layer provides a protective surface and is often self-healing when there is an oxygen source, such as air or water. In this case, it can be concluded that the comparatively low levels of chromium leached into the water indicates less damage to the protective oxide layer when compared to pure methanol. With less damage to the oxide layer, there is less access to the iron to leach into solution.

Figure 2: Stainless steel metal ion leaching into ultrapure water.

What remains unclear is to whether the nickel and iron metal contamination is a passivation effect or if it is truly corrosion of the material. The nickel and iron, along with their respective oxides, are much more easily extracted compared to the chromium oxide in the passive layer.<sup>3</sup> It is possible that the contamination seen here is simply the removal of the nickel and iron from the passive layer, and no underlying metal was attacked, leaving a purer chromium oxide surface. Subsequent studies will be necessary to evaluate which mechanism is at play in this situation.

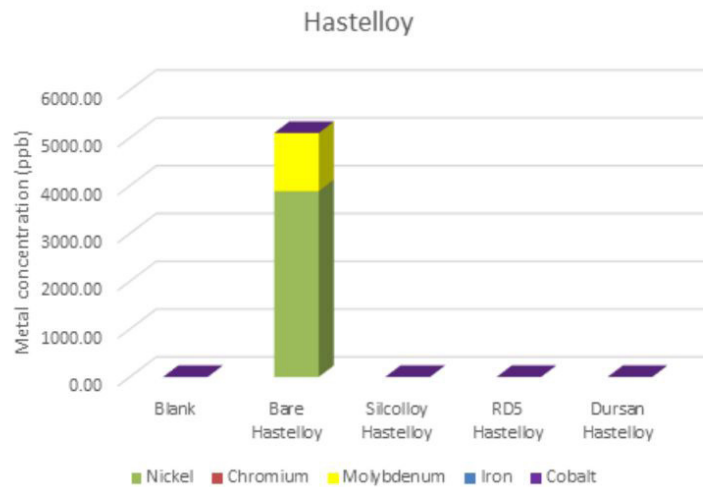
The results from the C-22 Hastelloy can be seen in Figure 3. Once again, the coated discs showed no evidence of metal ions leaching into solution. All three coatings provide sufficient protection from the DI water. Molybdenum and nickel were the major components of the metal ions in solution. It should be noted that the level of contamination was quite high compared to methanol. Table 2 is a comparison between the methanol and water contamination. Once again, the metal ions from chromium and iron are much lower in water when compared to the methanol experiment. Counter to what was seen in the 316 stainless steel alloy, there was a dramatic increase in the corrosion of other metals in the alloy. Most notably, nickel and molybdenum leached ppm levels of metal ions into solution. C-22 Hastelloy's oxide surface is composed largely of nickel, chromium, and molybdenum oxides. Chromium is clearly more stable in water where nickel and molybdenum suffer in water when compared to methanol. Just as with 316 Stainless Steel, it is unclear if this is a passivation effect or if this corrosion will continue with more time. Future studies are planned to determine this.

Figure 3: Metal ion contamination of ultrapure water from sintered C-22 Hastelloy discs.
