Protection Against Metal Ion Leaching due to Organic Solvent Exposure: Titanium and Stainless Steel Re-examination

Technical Insight

SilcoTek® Corporation

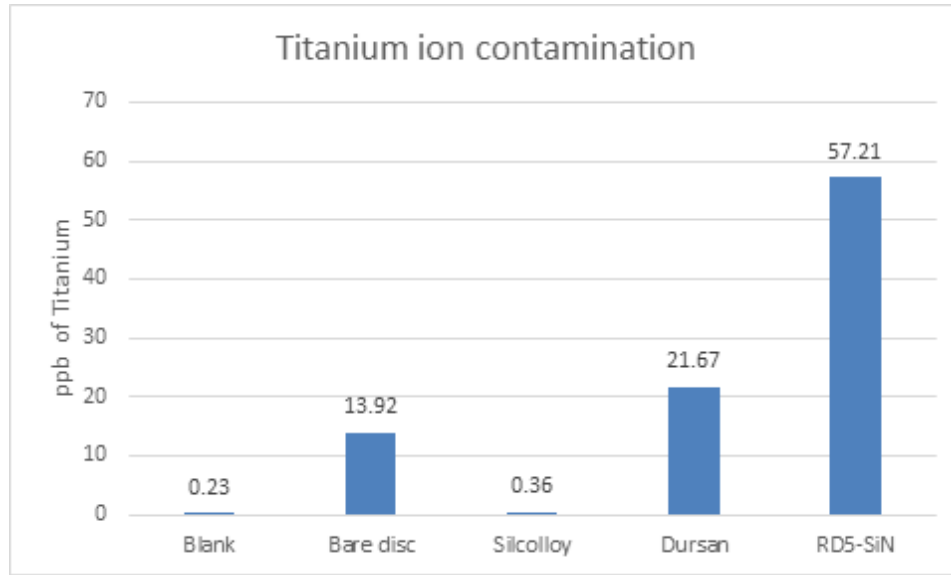
Figure 1 shows the detected titanium from the solution of each container. The blank represents how much titanium was in the methanol bottle. The bare disc represents how much titanium is leached into the methanol without any processing at SilcoTek Corporation.

Figure 1: ICP-MS results of the methanol solution after one month of soaking.

Silcolloy provides adequate protection to the titanium substrate from the methanol solution. It is nearly at baseline levels of titanium. The Dursan and RD5-SiN samples show significant titanium contamination of the methanol solution. This is likely due to the oxidative resistance of Silcolloy. Titanium is highly susceptible to oxidation, especially at high temperatures. Part of the Dursan and RD5-SiN processes, there are oxidations steps that are performed to create a more stable coating. These oxidation steps are performed at high temperatures and likely cause titanium, an element that is well known for diffusion at high temperatures, to come to the surface of the coating and become available to dissolve into the methanol during the soak. RD5-SiN is oxidized at a much higher temperature than Dursan. This causes a higher amount of titanium to diffuse through the coating.

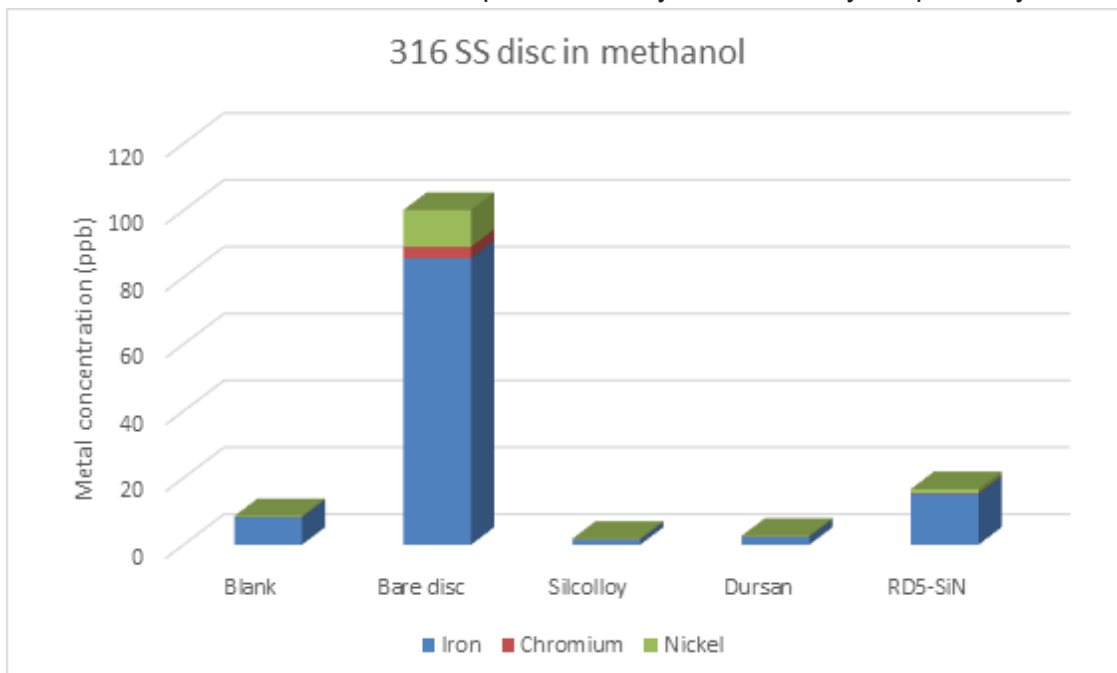
Figure 2: 316 stainless steel porous disc soaked in methanol for 1 month from TI 08-23-19.

It was noted in that TI, sample preparation may have been an issue causing contamination in the blank and RD5 samples. It seemed highly unlikely that Silcolloy and Dursan would have significantly lower concentrations of metals in the solution than the blank, which was run without any disc in the solution. Upon re-examination with more care taken in sample preparation (fresh gloves between samples and more care in resealing the containers after opening), the values look more reasonable as seen in Figure 3.

It is unclear as to why the bare disc in this study is an order of magnitude higher in total metal leaching into the methanol, compared to the original data illustrated in Figure 2. Some things that may affect this are things like temperature of the lab through the test, perturbation of the sealed containers during the 1-month exposure, variation in disc substrate or quality (see [here](#) for an example), or some other overlooked factor.

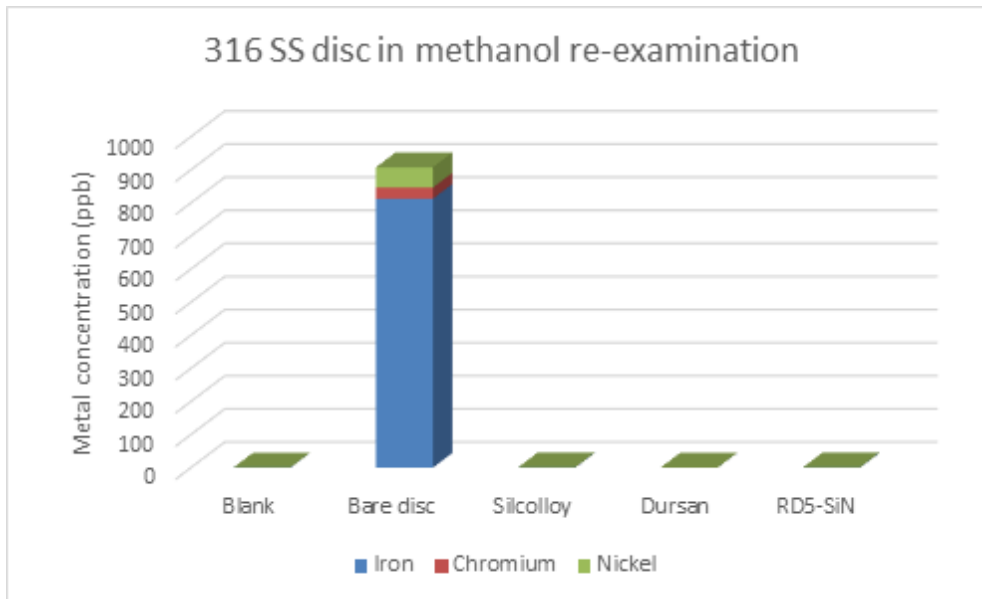
Figure 3: 316 stainless steel porous disc soaked in methanol for 1 month with more care taken in sample preparation.

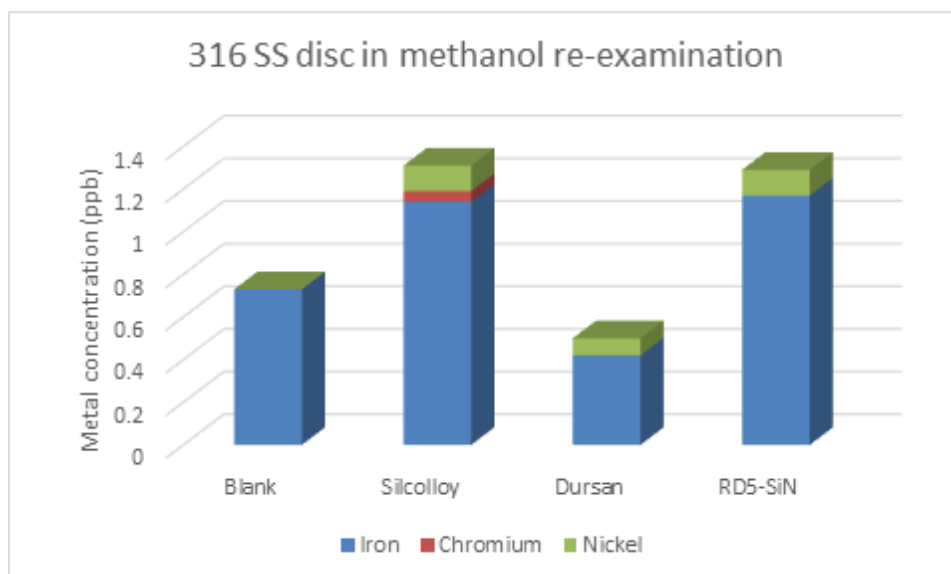
Due to the bare disc total metal value being so high, Figure 4 shows the blank solution as compared to the three coated discs. It should be noted that these values are very close to the detection limits of the ICP-MS for these elements (0.1-0.5 ppb) and are significantly lower than the total metal contamination from the uncoated disc, 908 ppb.

Figure 4: Stainless steel data without the bare disc for comparative purposes. The values are close enough to the blank to consider the metal ion contamination to be zero.
