# Protection Against Metal Ion Leaching due to Organic Solvent Exposure

## Technical Insight

# Protection Against Metal Ion Leaching due to Organic Solvent Exposure: Titanium and Stainless Steel Re-examination

# Metal ion leaching study in pure methanol part 3: C-22 Hastelloy

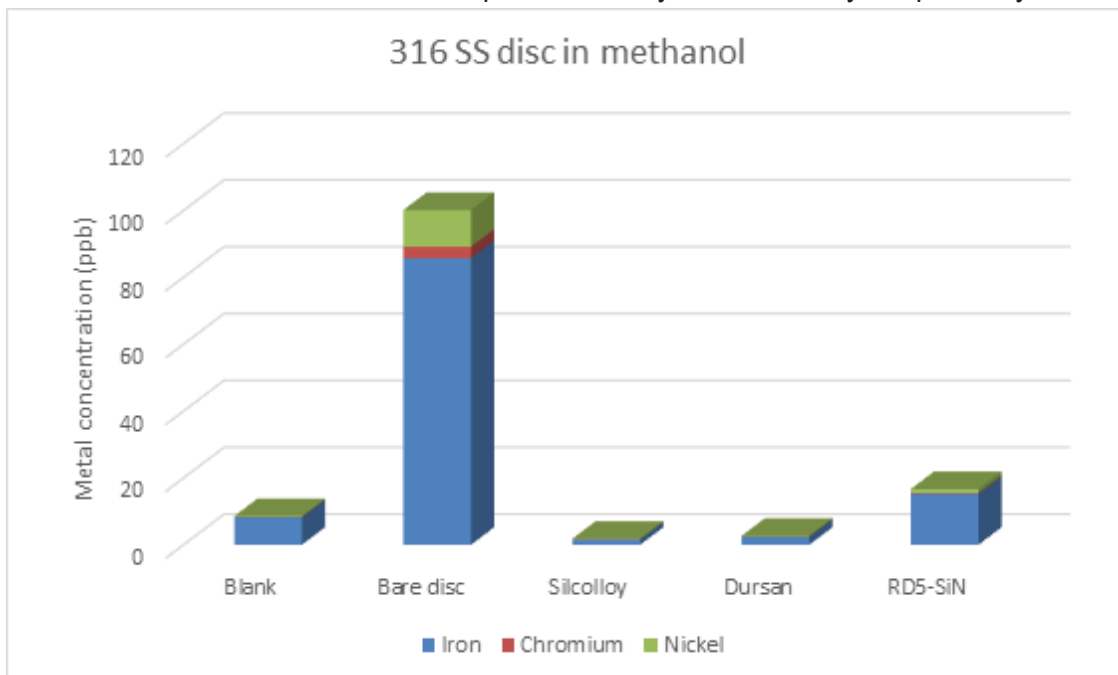
Figure 2: 316 stainless steel porous disc soaked in methanol for 1 month from TI 08-23-19.

As a part of this study, stainless steel discs were also tested as a follow up experiment to a [previous Technical Insight](#). Figure 2 and 3 show the results from the previous study and this study, respectively.

It was noted in that TI, sample preparation may have been an issue causing contamination in the blank and RD5 samples. It seemed highly unlikely that Silcolloy and Dursan would have significantly lower concentrations of metals in the solution than the blank, which was run without any disc in the solution. Upon re-examination with more care taken in sample preparation (fresh gloves between samples and more care in resealing the containers after opening), the values look more reasonable as seen in Figure 3.

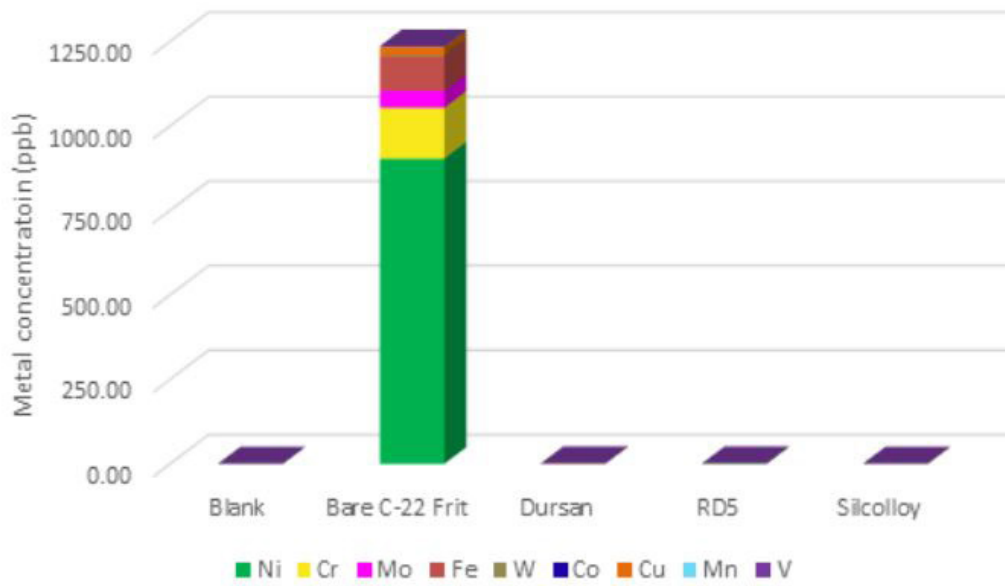
Figure 1: Metal ion concentrations in methanol. The blank is methanol from the bottle with no disc. The four others are a bare disc, and three SilcoTek corrosion coatings on a C-22 disc soaked in methanol for 1 month at room temperature.

Figure 1 shows the total metal ion concentrations from the solution of each container. The blank represents the level of metal ions in the methanol bottle, leached from the sealed container, sample preparation, or absorbed via environmental sources. The bare disc represents the level of metal ions leached into the methanol without any coating protection provided by processing at SilcoTek Corporation. Table 1 shows the raw values from each sample along with the total metal ion content. For reference, Table 2 is the composition of C-22 Hastelloy from Haynes International, the producer of Hastelloy materials.

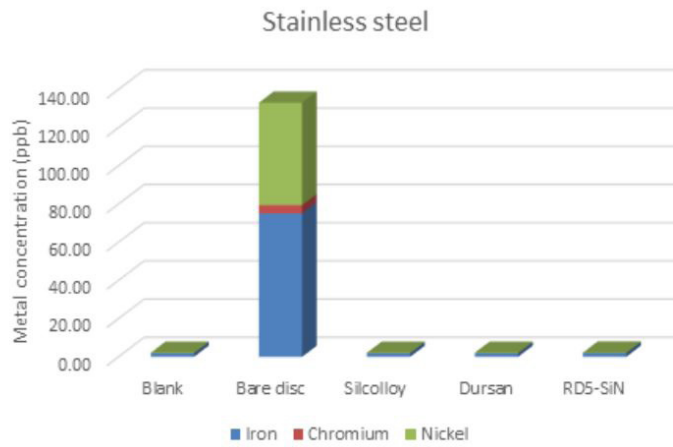
Figure 2: Stainless steel metal ion leaching into ultrapure water.

The 316 stainless steel disc results can be seen in Figure 2. It is obvious that the coatings on the sintered metal discs blocks the metal ions from leaching into solution. While there was substantial metal ion leaching into the solution, it was far less than experienced in the previous studies using methanol. Specifically, the iron and chromium levels were roughly an order of magnitude lower, as shown in Table 1. The nickel concentration is relatively unaffected by the solvent choice. The surface of 316 stainless steel has an oxide layer, largely consisting of chromium oxide, but also containing iron and nickel oxides. This layer provides a protective surface and is often self-healing when there is an oxygen source, such as air or water. In this case, it can be concluded that the comparatively low levels of chromium leached into the water indicates less damage to the protective oxide layer when compared to pure methanol. With less damage to the oxide layer, there is less access to the iron to leach into solution.

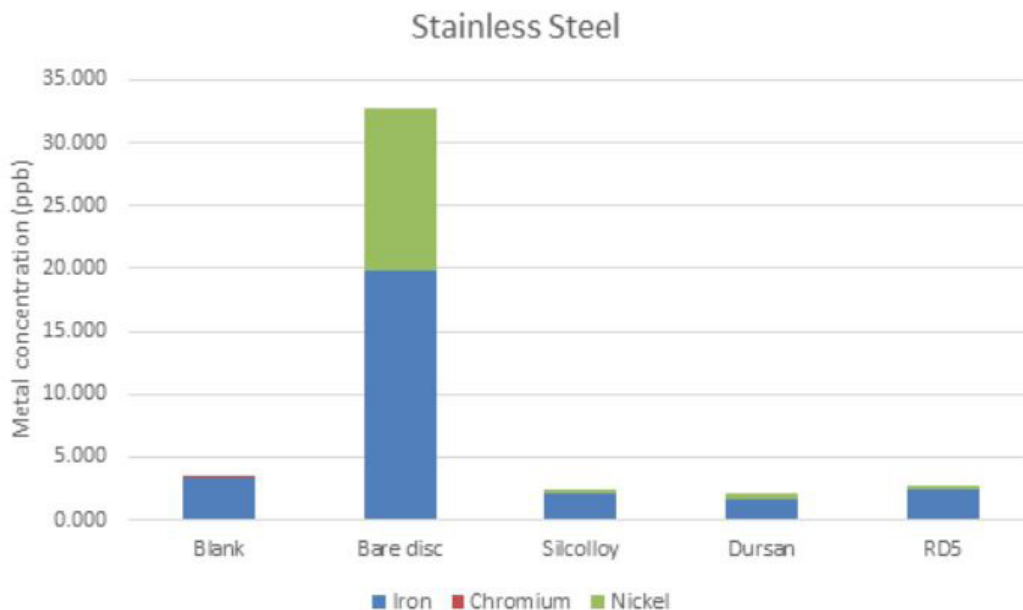
Figure 2: Stainless steel metal ion leaching into ultra-pure acetonitrile.

The 316 stainless steel disc results can be seen in Figure 1. It is obvious that the coatings on the sintered metal discs blocks the metal ions from leaching into solution. While there was metal ion leaching into the solution, it was far less than experienced in the previous studies using methanol and water. The results look similar to the water results where iron and nickel were on the same order of magnitude and chromium leaching was much less significant, as seen in Table 1.

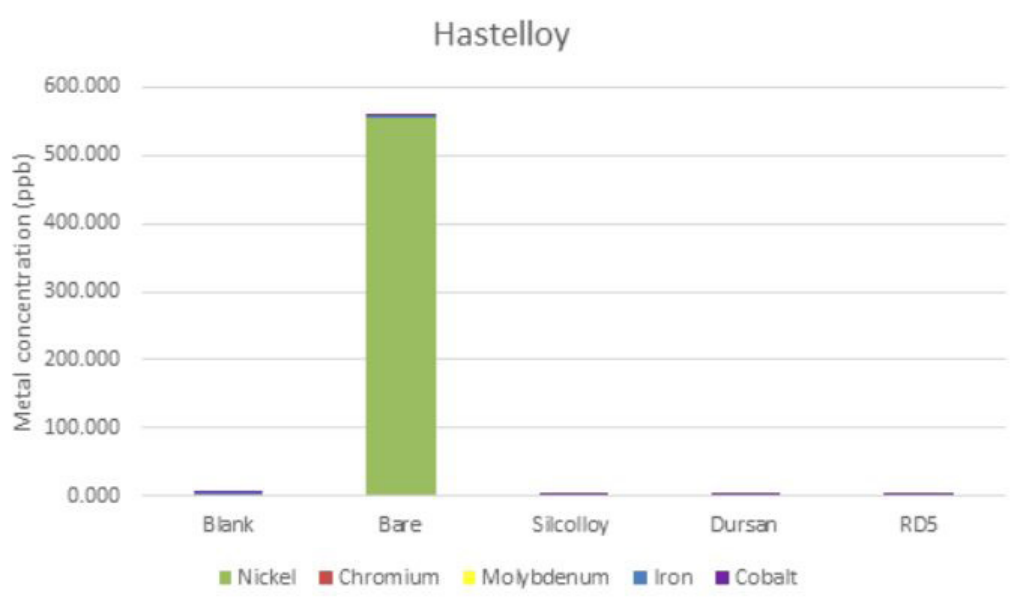
Figure 3: Metal ion contamination of ultrapure acetonitrile from sintered C-22 Hastelloy discs.

The results from the C-22 Hastelloy can be seen in Figure 2. Once again, the coated discs showed no evidence of metal ions leaching into solution. All three coatings provide sufficient protection from the acetonitrile. Nickel was the main contaminant in the acetonitrile along with a small amount of iron. Table 2 is a comparison between the methanol, water, and acetonitrile. As was the case with stainless steel, acetonitrile is the least aggressive solvent when it comes to the leaching of metal ions into solution. Hastelloy C was investigated by Mowery, and it was shown to be comparable to stainless steel in their high pressure tests. Here, C-22 Hastelloy is by far the worst metal ion leaching substrate that was tested.

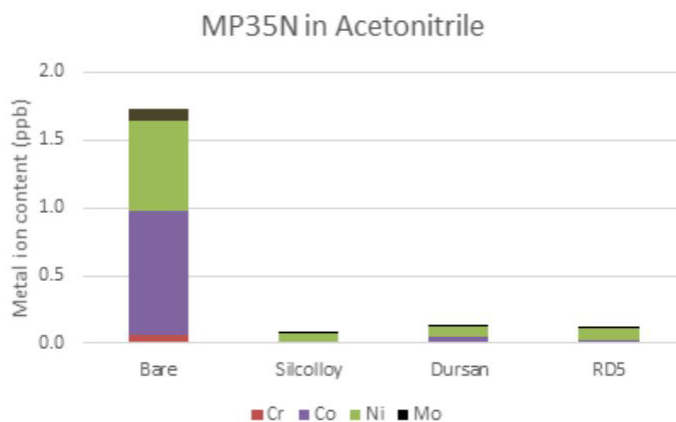
*Figure 2: Metal ions leached into methanol solution after one month of soak time. The coated samples were all at or near baseline levels of the methanol in the bottle.*

The results in acetonitrile can be found in Figure 2. There was a total of 1.73 ppb of metals leached into the acetonitrile solution. Compared to both methanol and water, acetonitrile appears to be the most benign solvent toward the alloys tested. Once again, the three coatings all provided sufficient protections against the leaching of metal ions into acetonitrile. All coated values were at the same level as the acetonitrile blank from the bottle.
