# Coating Parts with a Silver Plating

## Technical Insight

Min Yuan,  
R&D Scientist

SilcoTek® Corporation

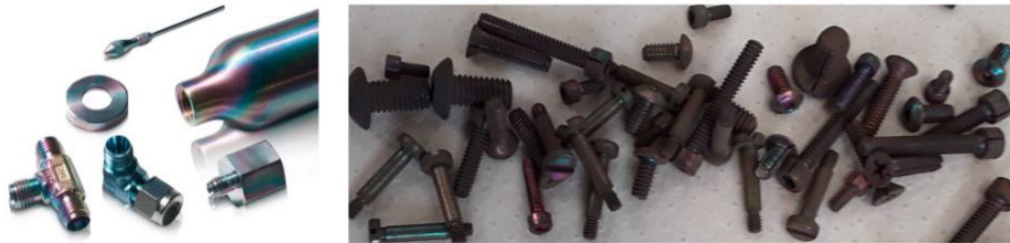
Figure 1: typical SN2000 output on SS parts (left), and SN2000 coating on a batch of customer-supplied silver-plated SS screws (right)

Typical SN2000 coating on stainless-steel parts exhibit nice rainbow patterns like shown in Figure 1 left. The customer-supplied screws, however, had an unappealing brown and flaky appearance that usually implies an incompatible substrate and would fail SilcoTek's visual QC inspection (Figure 1 right). This is in contrary to the results of a previous batch of silver-plated screws from the same customer, where everything coated successfully and passed inspection.

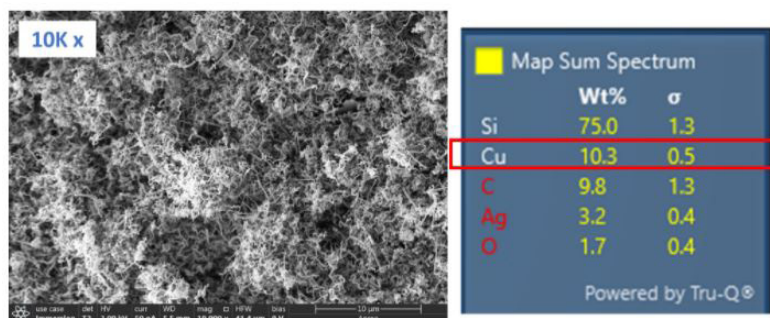
Figure 2: SEM (left) revealed that instead of a smooth film, silicon nanowires were found on coated screws (10K magnification), and a very high copper concentration was detected in the substrate via EDS (right)

With the customer's permission, we analyzed a few of the coated screws with SEM and EDS to look for answers. We found that instead of the smooth and conformal film coverage expected from a normal SN2000 coating, the screws were covered by clumps of nanowires made of silicon (Figure 2 left). EDS analysis also revealed a surprisingly high copper content in the substrate, higher even than silver, the plating metal that is supposed to cover the surface of the base stainless-steel (Figure 2 right). The presence of copper explains the abnormal coating results experienced by these screws, as copper and copper alloys (such as brass and Monel) are known to catalyze nanowire growth of silicon (i.e. one-dimensional wire growth instead of a planar film growth that covers the entire substrate surface), and for that reason were listed as incompatible substrates on [SilcoTek's website](#).

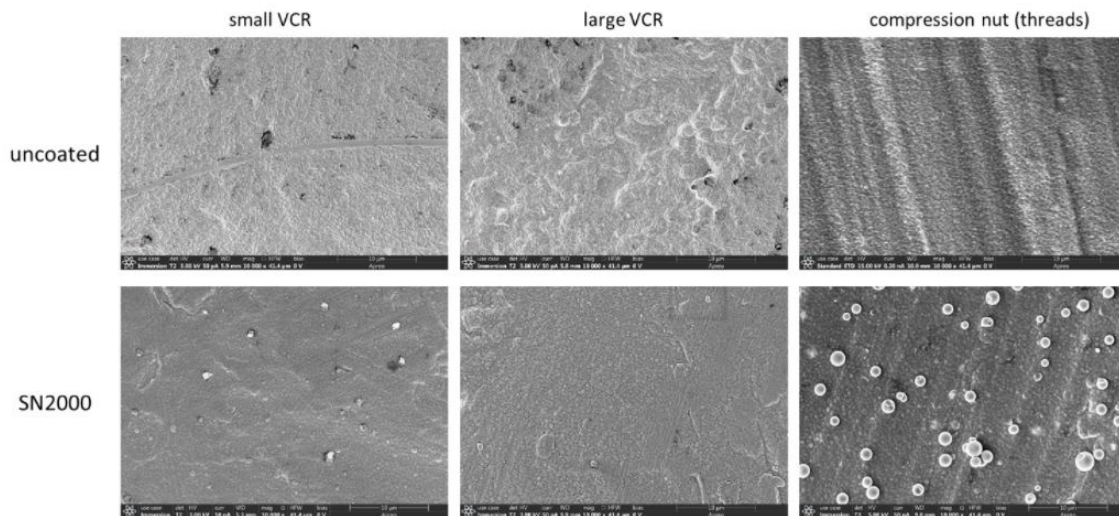
Figure 4: uncoated (top) and SN2000-coated Swagelok VCR gaskets and compression nut (all silver-plated) under SEM (all taken at 10K magnifications); no silicon nanowires were found

SEM and EDS analyses were performed on the coated as well as uncoated Swagelok test parts to examine if there is similar nanowire growth on these parts. Figure 4 combines the uncoated and coated SEM images of each test part next to one another for comparison. No silicon nanowire growth was observed on any of the coated parts. The uncoated surfaces showed various degrees of roughness, while the coated surfaces appeared smoother in general in comparison. The SEM image of the coated compression nut showed some silicon particles that could not be completely removed via post-cleaning methods (i.e. CO<sub>2</sub> blow off and sonication). Silicon dust particles are a side-product of the SN2000 CVD deposition reaction and can sometimes adhere to a coated surface.
