SilcoTek Coatings in a Venusian (Pure Supercritical CO₂) Atmosphere*

Technical Insight

* This Technical Insight is a summary of a technical report provided by the NASA Glenn Research Center; Cleveland, OH.

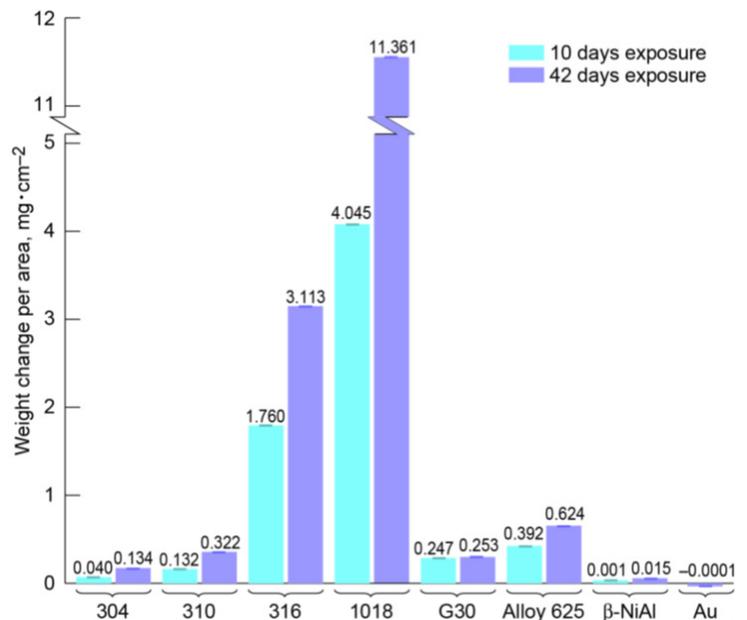
Figure 1: Weight change per area of various metal coupons placed in the GEER and exposed to the Venusian atmosphere.

Figure 1 shows the weight change in all of the bare metal alloys. The carbon steel (1018) shows the worst performance, followed by the three grades of stainless steel (316, 310, and 304). The nickel alloys and gold will not be discussed here as they were not coated for testing; however it is worth noting that the results of the SilcoTek

coatings were on par with the specialty nickel alloys.

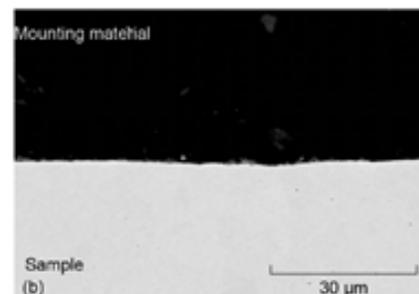
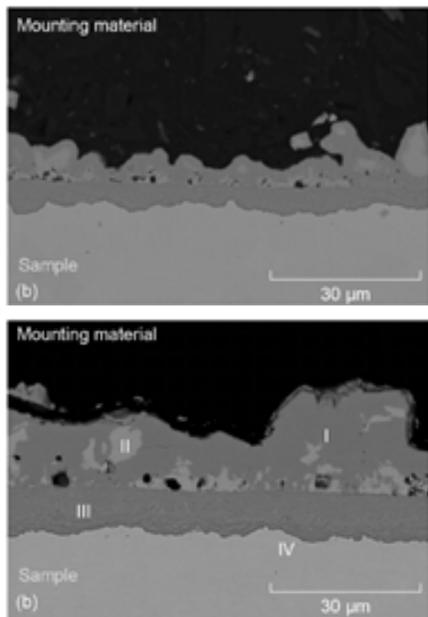
Figure 2: Backscatter electron images of 316 stainless steel coupon cross-section with 0,10, and 42 days of exposure to the Venusian atmosphere.

The bare stainless-steel coupons developed a double layer exterior in which the outer layer is mostly magnetite (Fe₃O₄) and the inner layer is a nickel sulfide. These are formed from the exposure at both 10 and 42 days in the GEER. Figure 2 shows cross sections of the 316 stainless steel before and after exposure. Other oxides were found in the steels as well, but they were much less abundant. Carbon steel was found to have layers that were rich in iron, sulfur, and oxygen. This was largely from the formation of iron sulfide and a multitude of oxide phases. Both layers are not well bonded to each other and are porous which can potentially cause flaking issues. The sulfide formation can be attributed to the SO₂ reaction with the steels, and the oxide is similar to that which is found in previous studies of supercritical CO₂ and its interaction with steels.

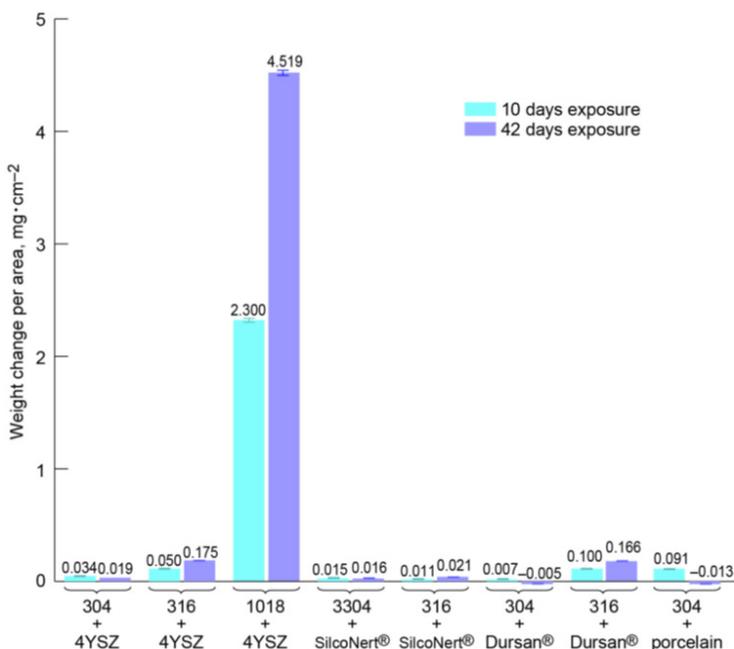
Figure 3: Weight change per area of various coated metal coupons placed in the GEER and exposed to the Venusian atmosphere.

Figure 3 shows the weight change for the Dursan and SilcoNert 1040 along with the YSZ and a porcelain coating after exposure in the GEER. YSZ was shown to be a semi-porous coating, as the supercritical CO₂ was able to penetrate through to the steel surface to start the oxidation process. The YSZ simply slowed this oxidation. NASA ranked the coatings as SilcoNert 1040>porcelain>Dursan>YSZ in terms of weight gain observations.

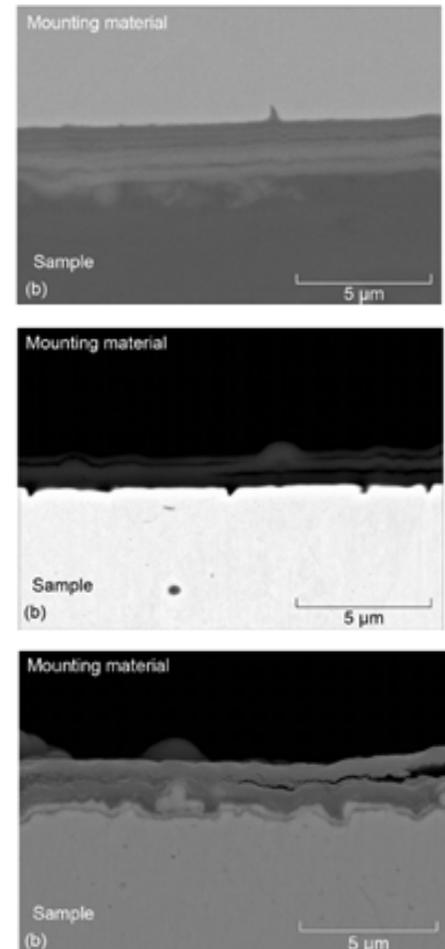
Figure 4: Backscatter electron images of the cross-section of 316 stainless steel with the SilcoNert 1040 coating. From top to bottom, exposure days are 0, 10, and 42.

XRD analysis of the coupons before and after exposure shows that the SilcoNert 1040 worked well to stop any corrosion of the stainless steel surfaces. Prior to exposure, only austenite and ferrite were detected. The SilcoNert coating is amorphous, which would result in a very broad peak in the XRD; however, due to the very thin nature of this coating, it was not detectable in NASA's setup. After exposure, these coupons showed iron silicide phases along with the austenite and ferrite suggesting that there was some sort of reaction between the steel substrate and the coating. According to XPS analysis, it was still effective in protecting the steel as there was no evidence of Venus gas penetrating into the bulk of the coating or substrate. Figure 4 is a good illustration of the protective qualities of SilcoNert 1040. After 42 days of exposure to the Venusian atmosphere, the 316 stainless steel has not been attacked like what is seen in Figure 2.

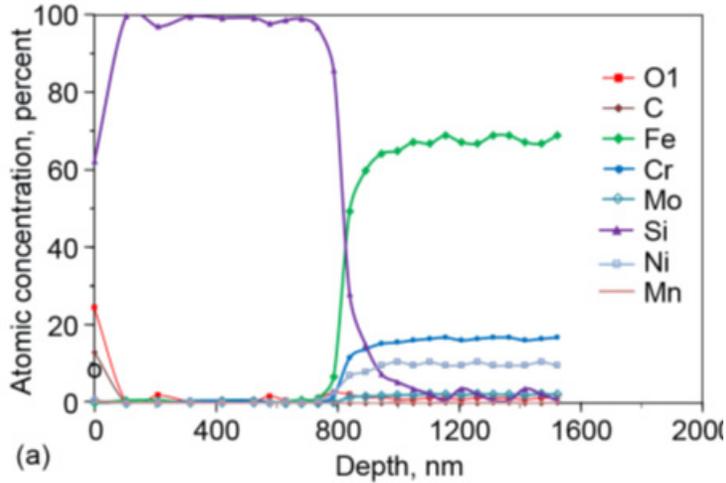
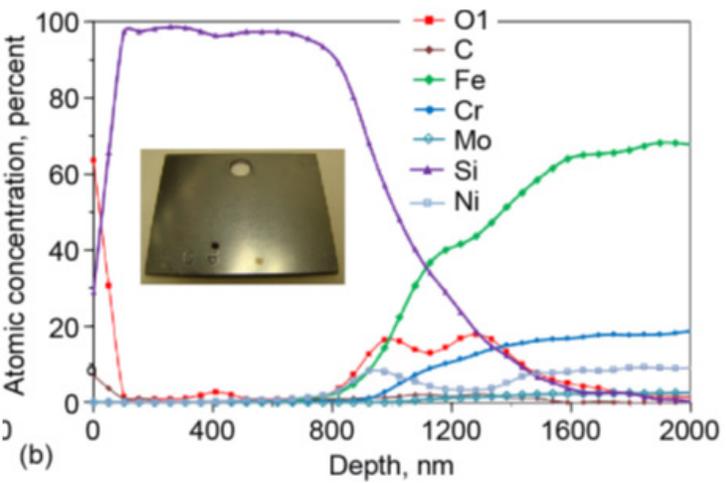
Figure 5: XPS depth profile of a 316 stainless steel coupon before (a) and after (b) exposure to the Venusian atmosphere for 21 days.

XPS analysis of the SilcoNert 1040 coating, seen in Figure 5, shows that while there was some reaction of the silicon from the coating with the iron and chromium of the steel at the interface, none of the Venusian gas was able to penetrate into the bulk of the coating, nor the 316 steel substrate.

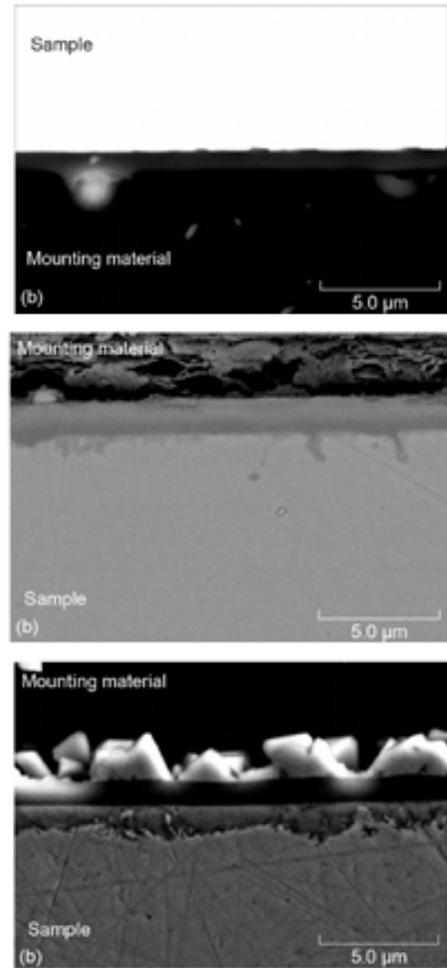
Figure 6: Backscatter electron images of the cross-section of 316 stainless steel with the Dursan coating. From top to bottom, exposure days are 0, 10, and 42 (note that day 0 is upside down compared to all other cross sections).

The Dursan-coated stainless steel also showed only austenite and ferrite prior to exposure. After the exposure, iron silicon oxide and iron nickel silicide phases were detected suggesting that, like SilcoNert, the Dursan and the substrate underwent some sort of reaction. Figure 6 shows the cross-section of a Dursan-coated coupon, and it appears to be very similar to SilcoNert, where it provided adequate protection of the steel.

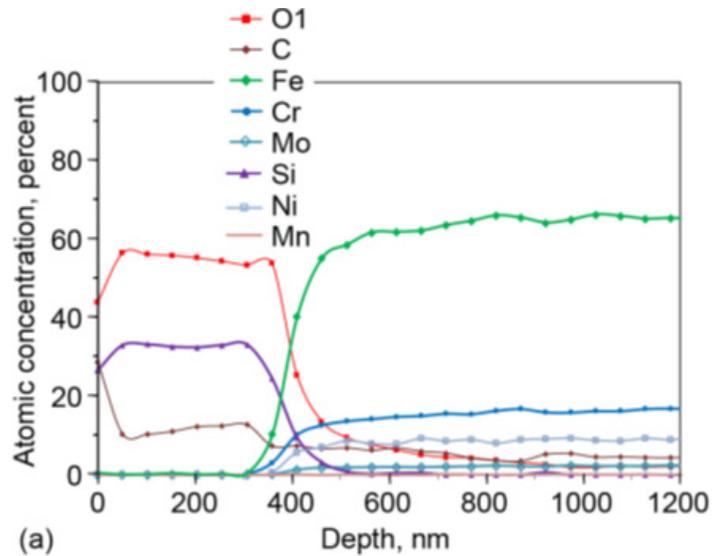
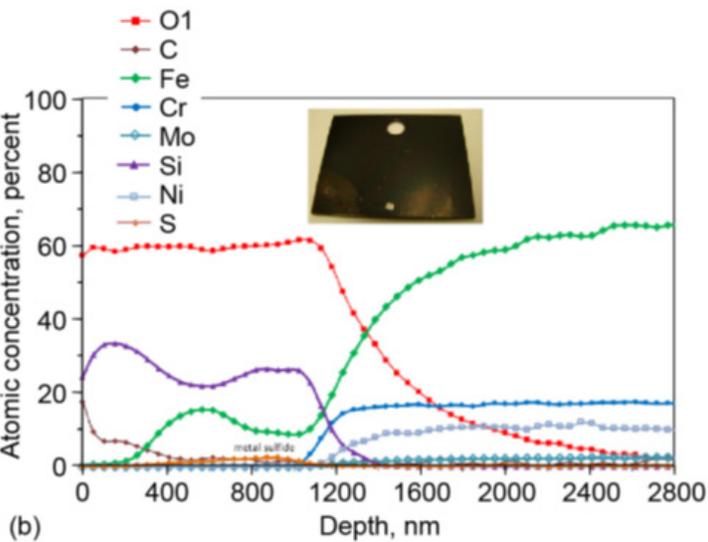
Figure 7: XPS depth profile of 316 stainless steel before (a) and after (b) 21 days of exposure to the Venusian atmosphere.

Unlike the SilcoNert coating, XPS depth profiling showed evidence of a metal sulfide at the interface between the coating and steel suggesting that some amount of the Venusian gas was able to penetrate through the Dursan coating. This can be seen in Figure 7, which shows a before and after XPS of a 316 stainless steel coupon.
