## 100% chlorine gas corrosion test results at room temperature and 150°C

### Technical Insight

SilcoTek® Corporation

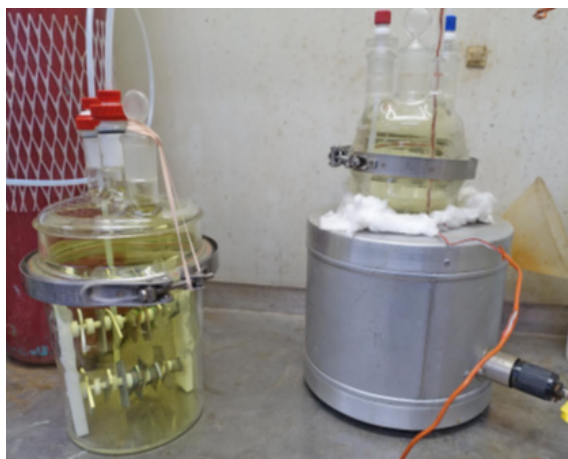
*Figure 1: Test vessels filled with chlorine gas*

The test specimens were loosely mounted on PTFE rods separated from each other by PTFE spacers. The rods were attached to legs which kept the specimens suspended within the appropriate test vessel, see Figure 1. The test vessels consisted of glass resin kettles with removable lids. The lids contained ports for gas inlet and outlet and a thermowell for monitoring the temperature. The gas delivery apparatus consisted of a flow meter, associated tubing (stainless steel and PTFE), valves, and fittings. The test vessels were connected in series, with gas from the flowmeter connected to the inlet of the room temperature vessel. The outlet of the room temperature vessel was connected to the inlet of the 150°C vessel. The outlet of the 150°C vessel was routed to a vapor tap and then to a caustic scrubber. The 150°C vessel was placed in a heating mantle that was connected to a temperature controller.

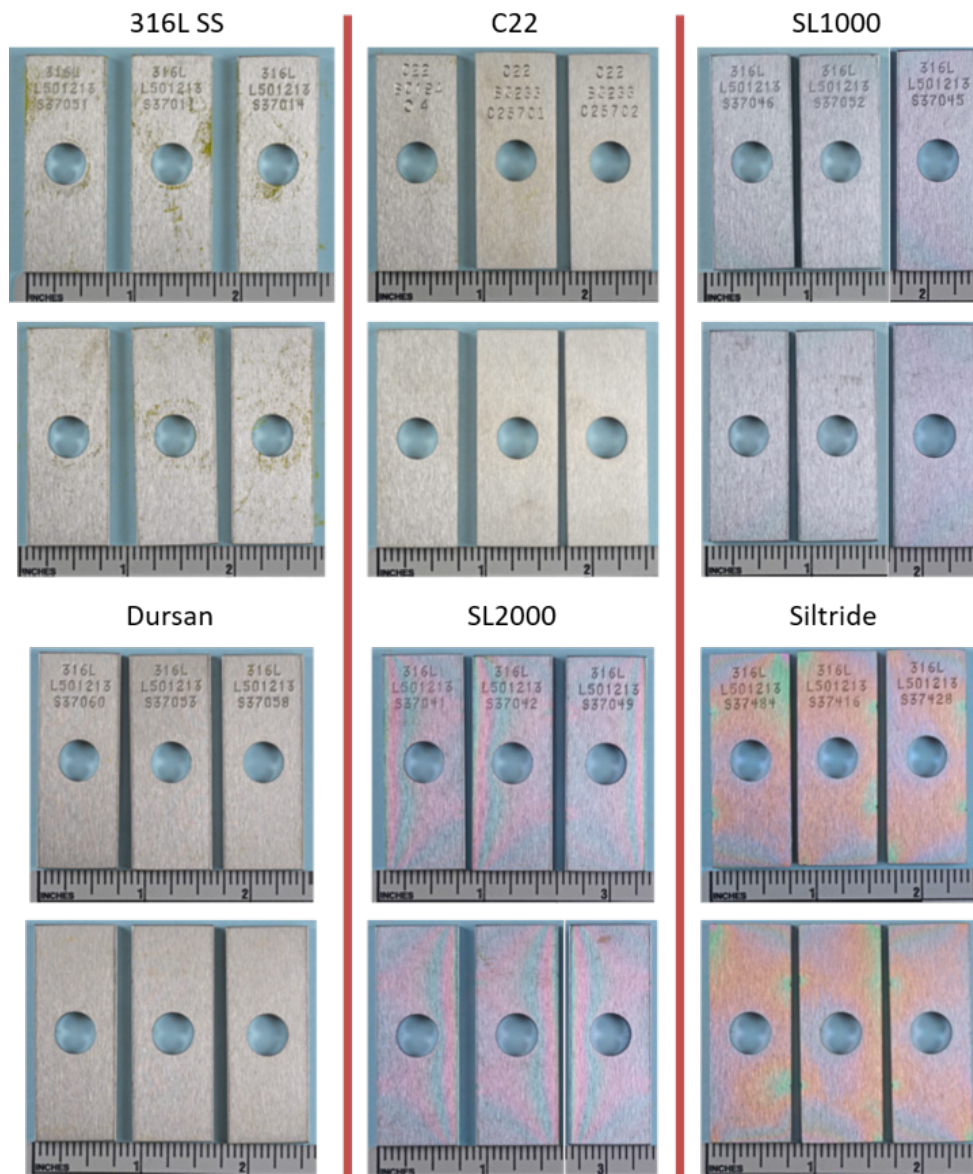
Figure 2: Photographs of all coupons (front and back side) immediately after removal from the room temperature test vessel without any rinsing

The test specimens were examined visually for evidence of corrosion and photographed without any rinsing. Photographs of the specimens are presented in Figures 2 and 3. For the room temperature exposure (Figure 2), the uncoated 316L SS coupons had green deposits present. The green deposits were loosely adhered and after were removed with a subsequent water rinse, there were visible areas of metal loss underneath the deposits. The uncoated Hastelloy C22 coupons showed slight green discoloration in some areas, both front and back. Among the coated coupons, both SL1000 and SL2000 showed a few localized smudges but otherwise unchanged. Dursan and Siltride showed no visual changes before and after the exposure.

The uncoated 316L SS coupons exhibited the most visible corrosion spots as seen in Figure 2, and these spots showed up as roughened areas under SEM (Figure 5 top). A slight uptake in Cl (0.1%) was also detected by EDS. The Cl content was likely low because most of the chloride corrosion products were washed away during the previous sonication step. The uncoated Hastelloy C22 coupons showed significantly less corrosion spots than 316L SS. A few corrosion spots were identified and showed up as micro-cracks under the SEM (Figure 5 bottom). A moderate Cl uptake (1.5%) was detected by EDS. The chlorine uptake was attributed to chemisorbed chlorine species to the metal surface, an indication of corrosion initiation but the corrosion reaction did not proceed as far as on the uncoated 316L SS samples.
