Removing Rust Prior to Coating

Abstract

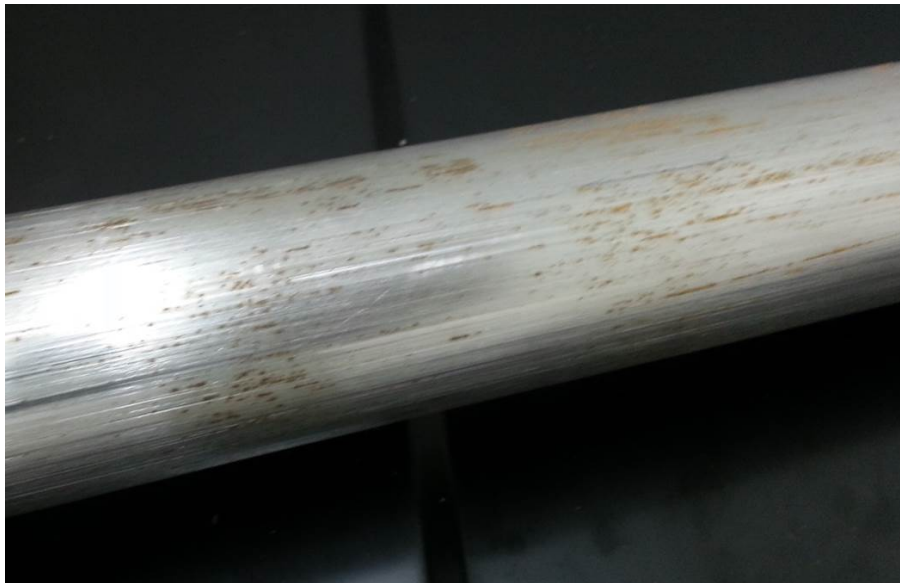
Figure 1 - Stainless steel part showing rust of surface free iron.

Below is an example of a part which showed rusting prior to coating and the results from our recommended acid treatments.

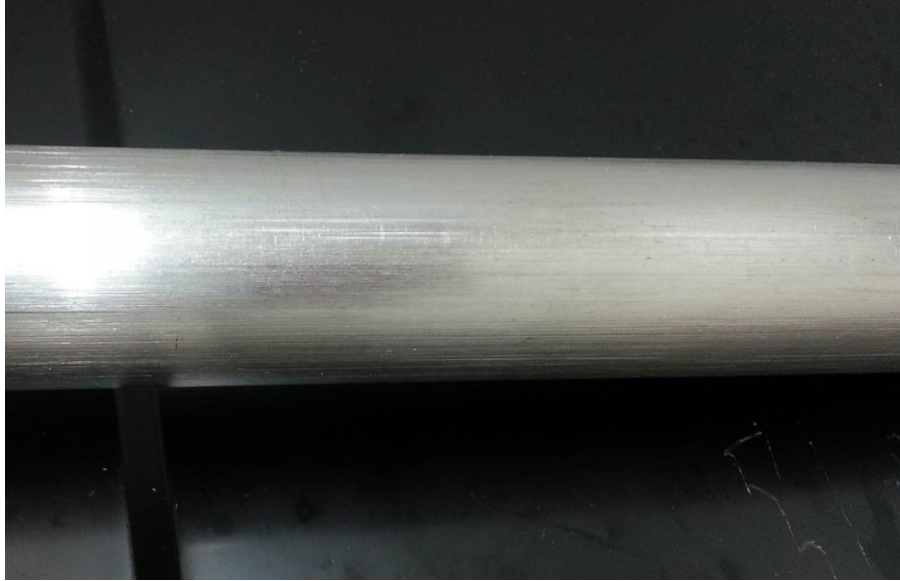
Figure 2 - Stainless steel part following treatment with phosphoric acid removal of surface rust.

Phosphoric acid will dissolve iron oxide without attacking the other components of the steel (chromium and chromium oxide, nickel, and iron). The rust is dissolved by the following reaction:

Phosphoric acid is readily available from a number of commercial suppliers (SilcoTek uses 85% 'food grade') and it can be used with no dilution because of its non-aggressive nature. Clean up after acid treatment is done by rinsing parts in deionized water thoroughly and then returned to the coating process. Unfortunately, this technique is not 100% effective on all the forms of iron oxide and other surface preparation treatments could be necessary.
